3.7 TRANSPORTATION AND CIRCULATION

The Emerson Property includes 140 acres and is located north of Cypress Road within the proposed 303-acre Dutch Slough Area in the City of Oakley. The Emerson Property is proposed for residential development consisting of 578 single-family residential units. The project is proposing to include four different neighborhoods with lot sizes ranging from approximately 3,000 to 6,000 square feet. The project would also include a shopping center with approximately 280,000 square feet of commercial space anchored by a supermarket.

FIGURE 1 | PROJECT LOCATION AND STUDY INTERSECTIONS
TRAFFIC IMPACT STUDY
Emerson Ranch
City of Oakley

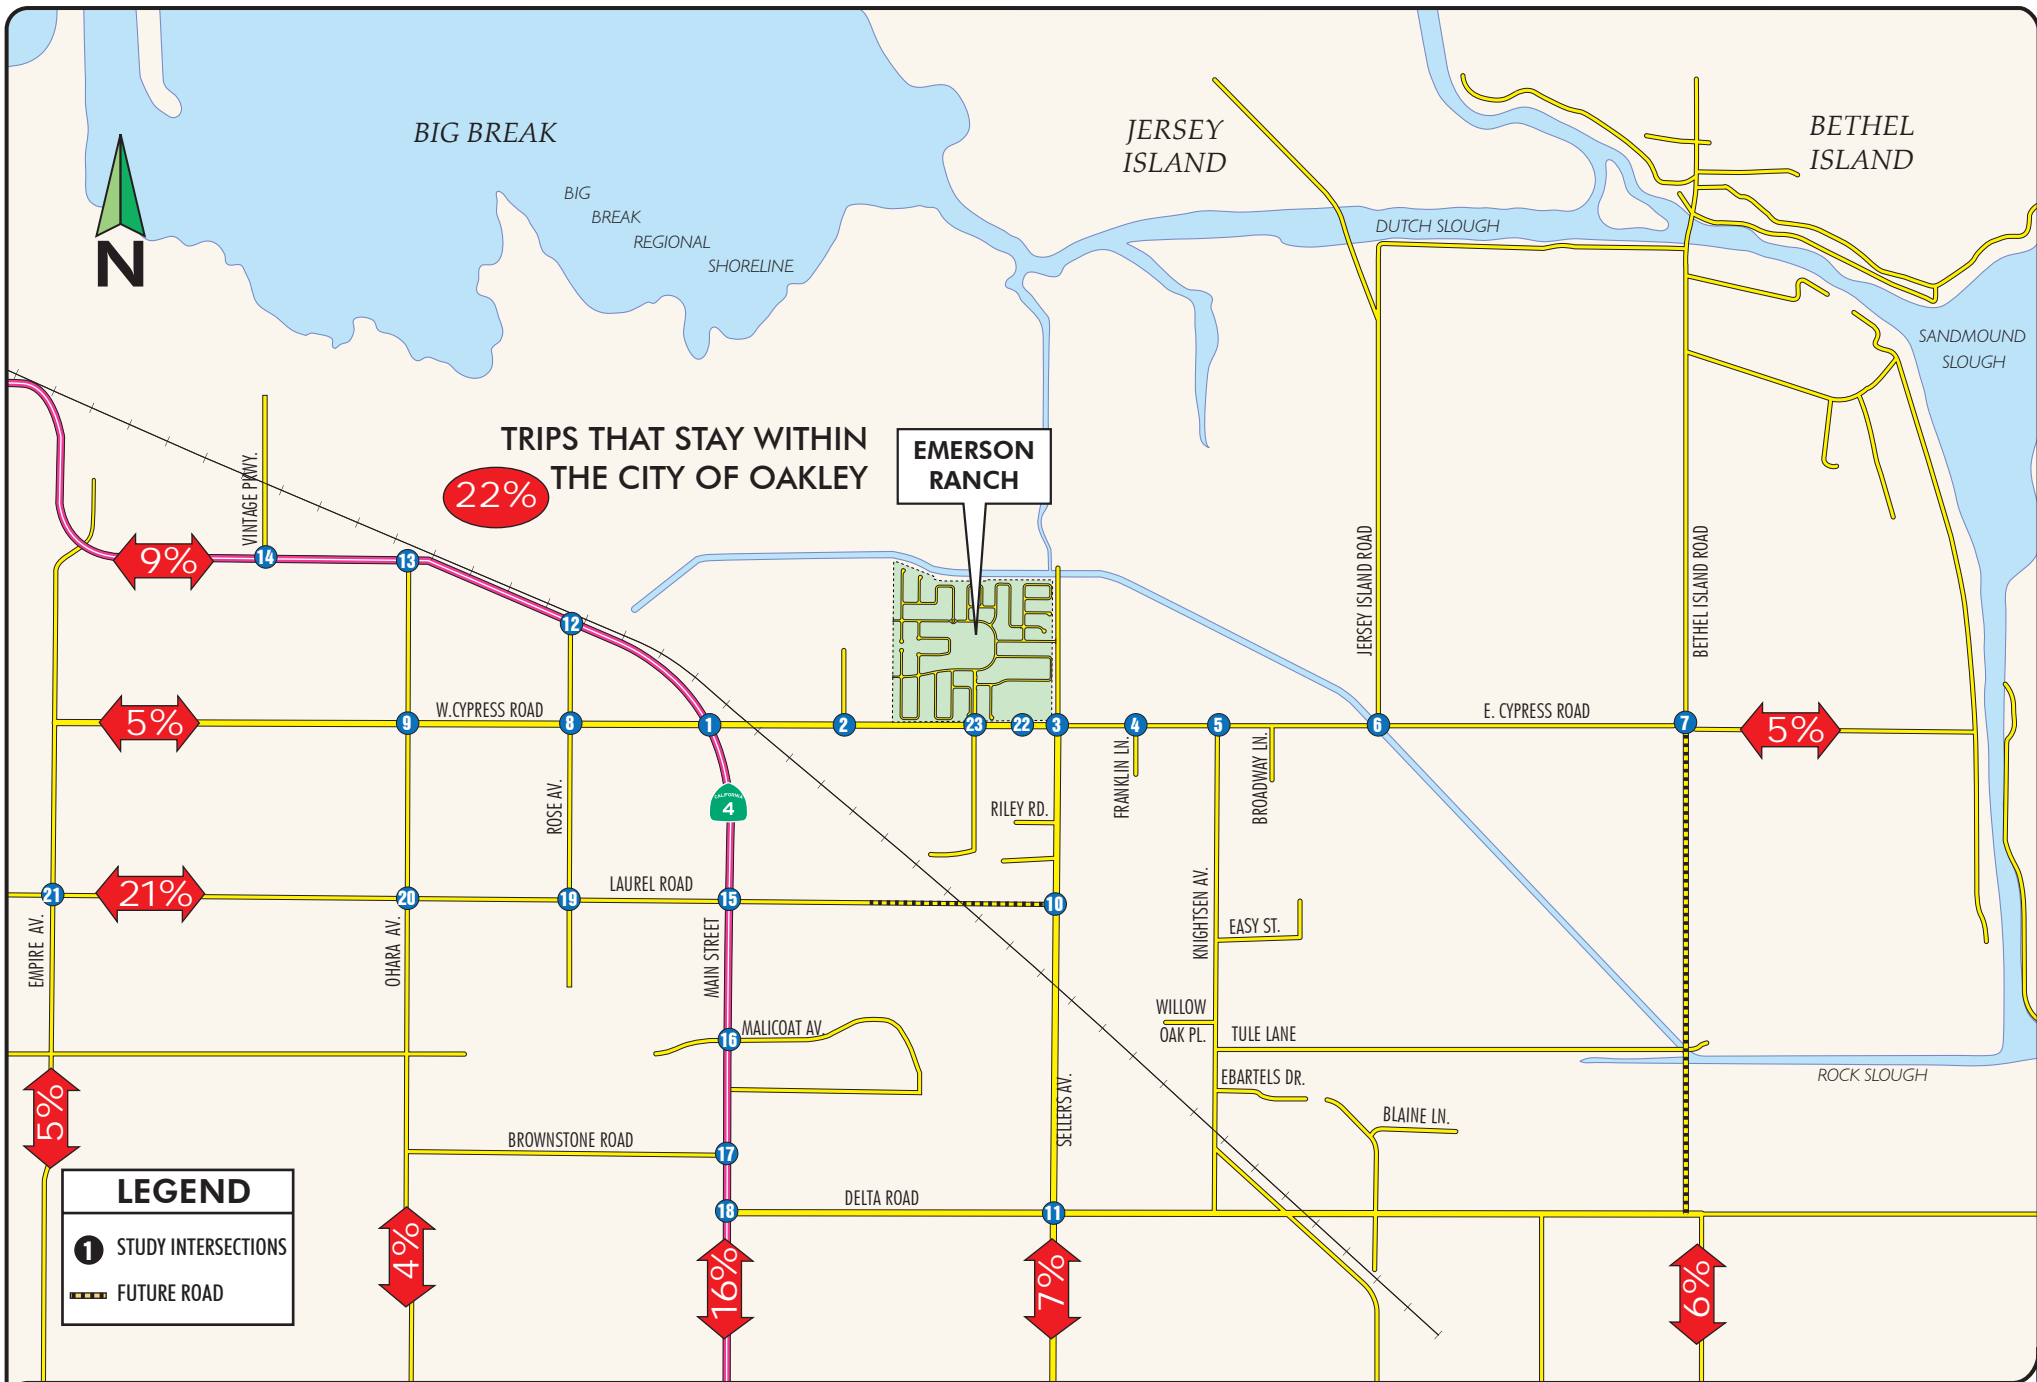
FIGURE 7 | TRIP DISTRIBUTION
TRAFFIC IMPACT STUDY
 Emerson Ranch
 City of Oakley

Figure 7 shows the trip distribution percentages that were used in the analysis. Figure 8 shows the resulting existing plus project turning movements at each of the study intersections. Although Cypress Road would remain the primary access to the project, in the future a large portion of the traffic from this area is assumed to travel to and from the south on Sellers Avenue to access the SR 4 Bypass via the planned extension of Laurel Road. It should also be noted that it is forecast that approximately 22 percent of the project traffic would be internal trips within the Oakley city limits.
